FINAL REPORT
STRUCTURAL INVESTIGATION

1845 - 1902 CAPITOL BUILDING

TALLAHASSEE, FLORIDA

3 MAY 1978

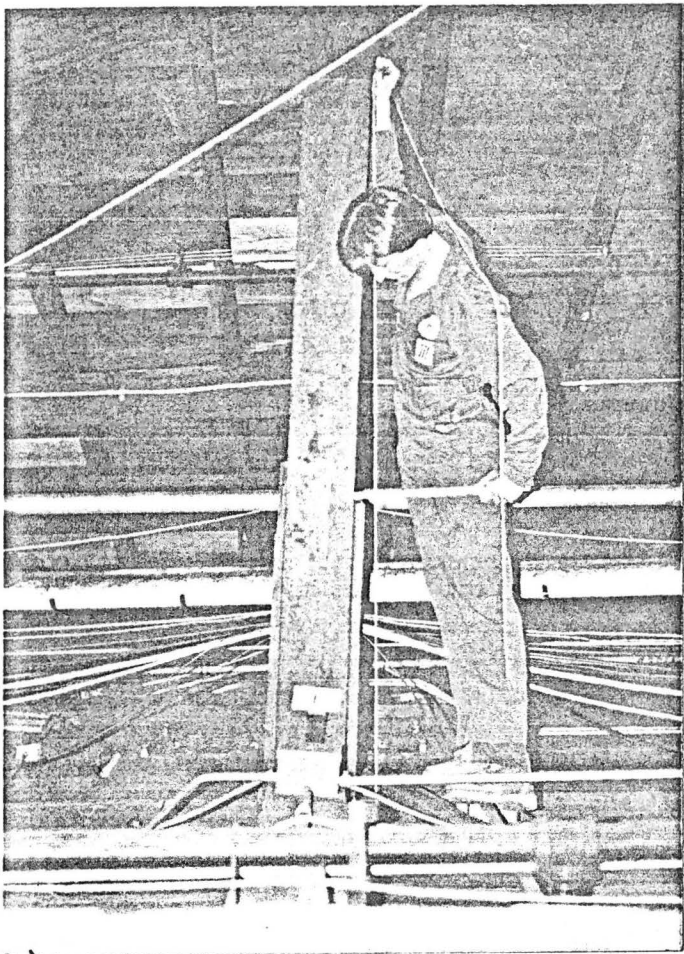
1. Frame N_1 support column leaning $N^\pm 2''$

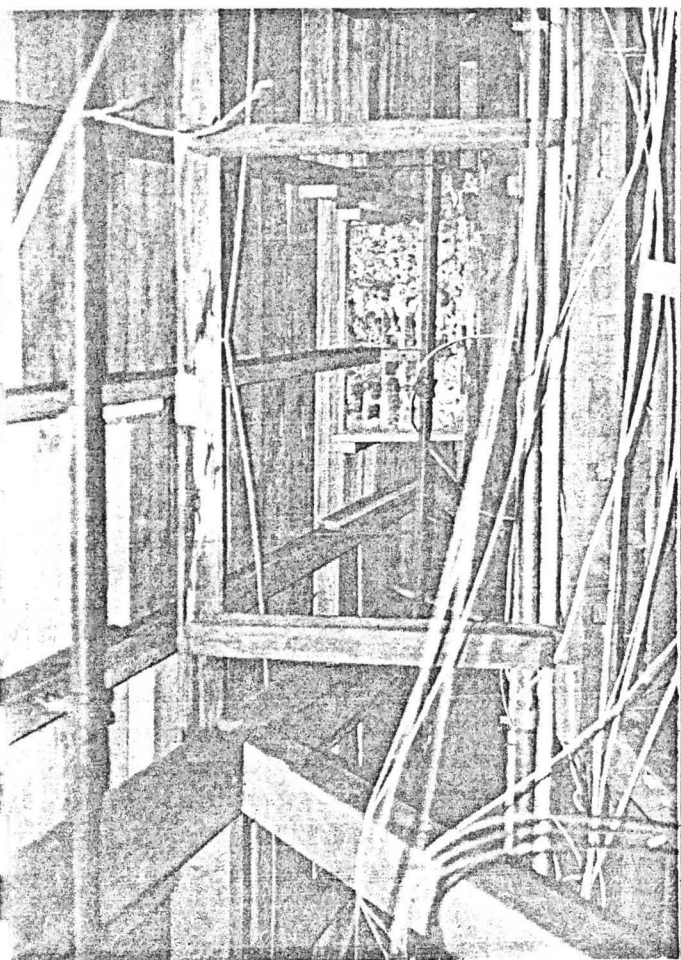
3² Replaced purlin between N₂ & N₃

3³ Replaced purlin between N₂ & N₃

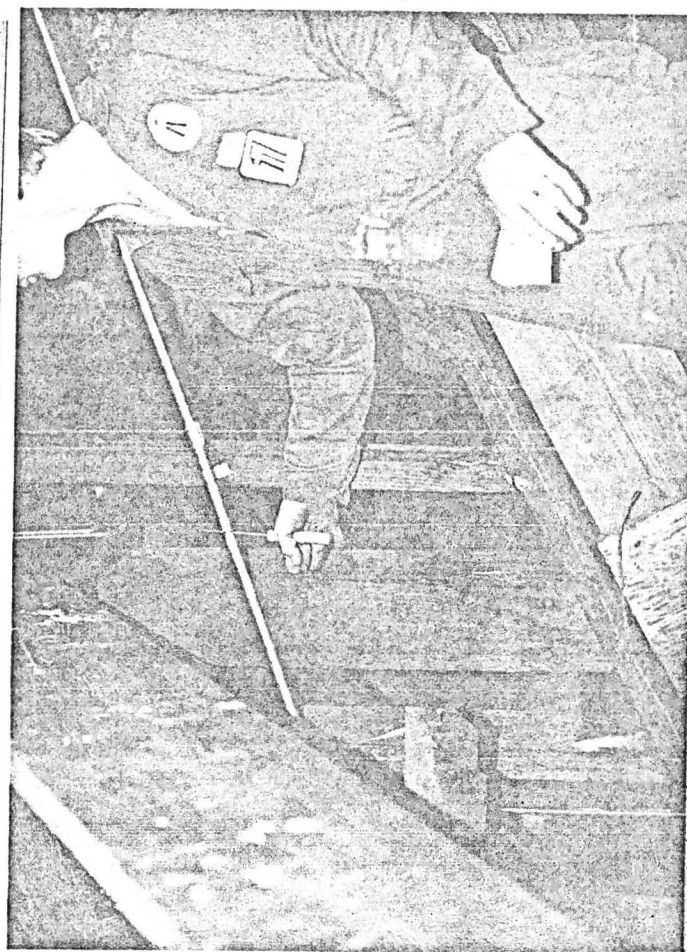
14³ Gap showing movement near dome

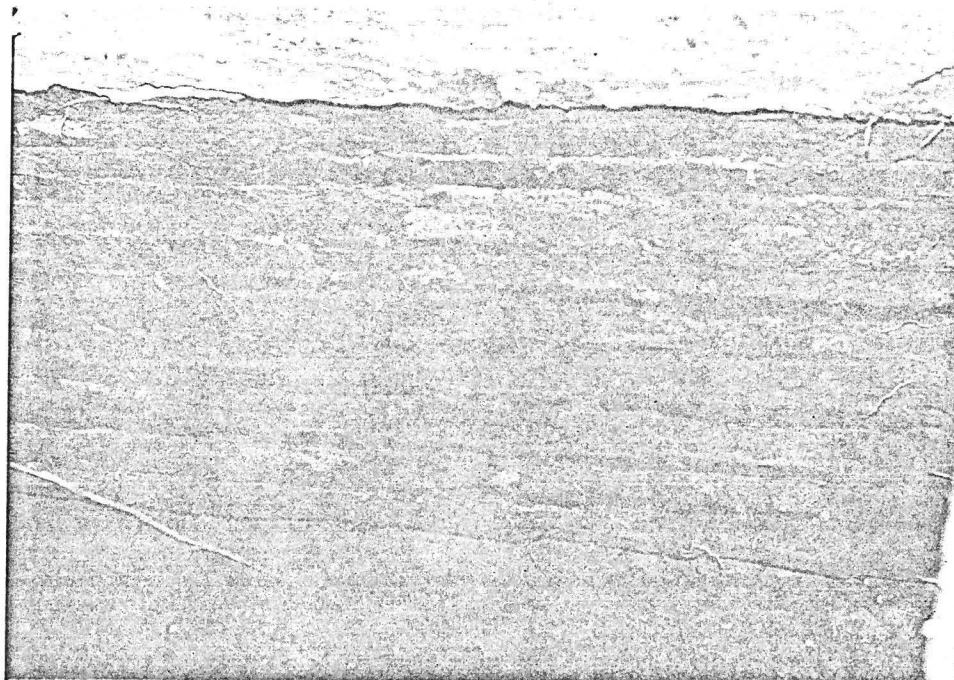
59. East footing of 1845 building

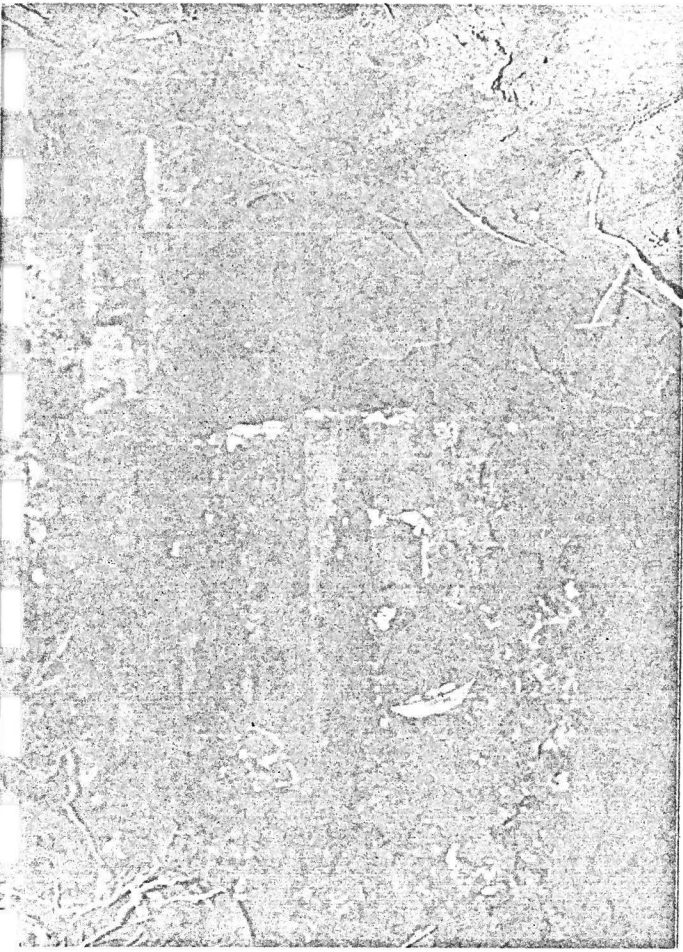
60. Intersection of footing of the East
1922 and 1845 building

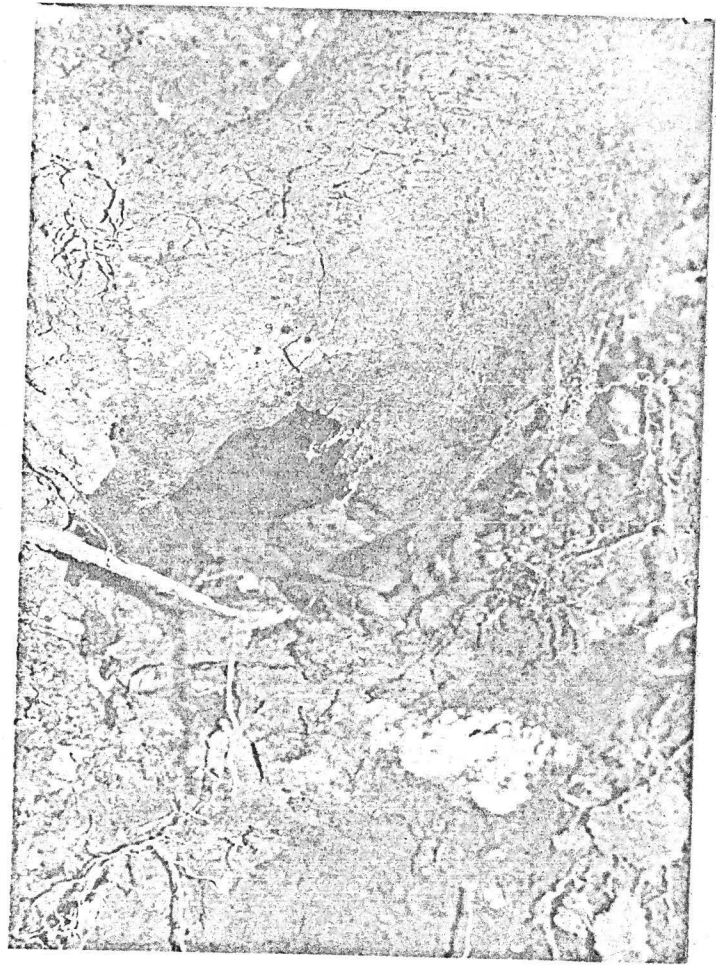
61. Roof drain tile below grade with hole
allowing water to keep footing wet

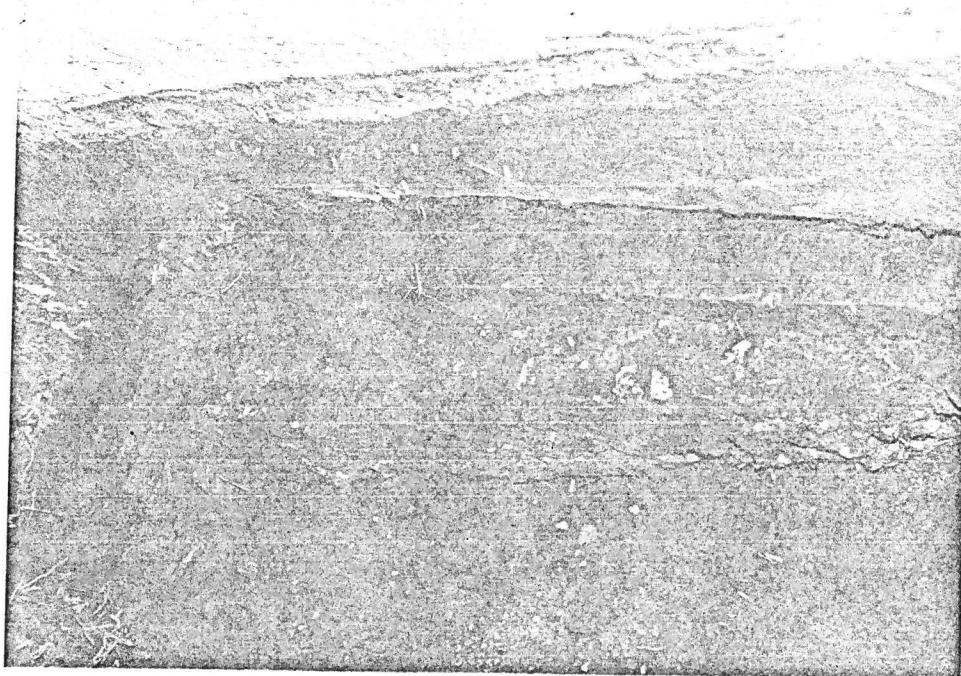
62. Intersection of 1902 addition and 1845 building @ N.E.
Corner

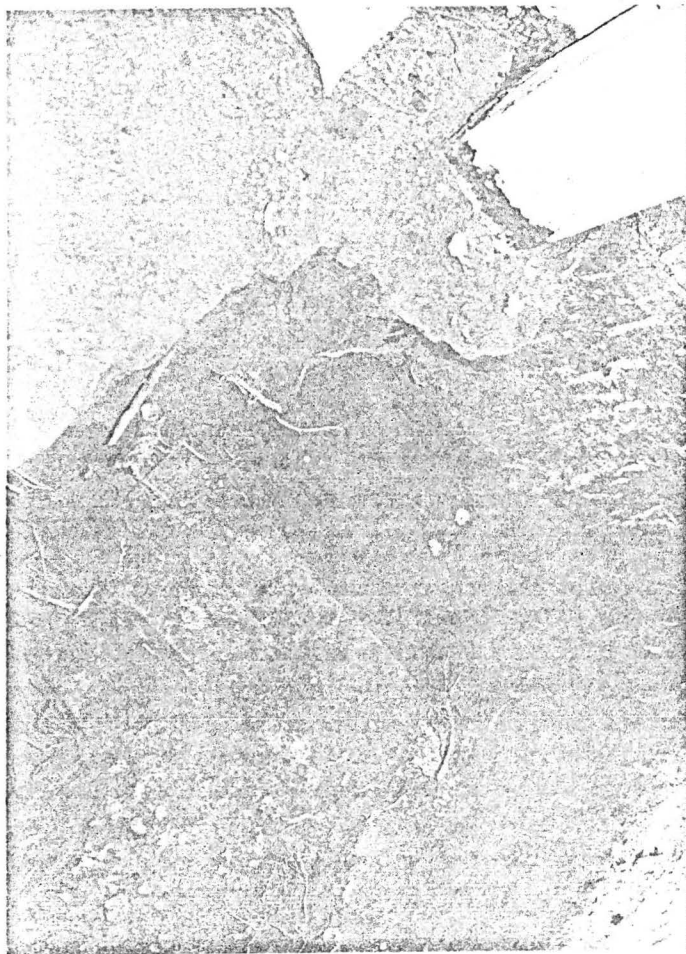
63. Drain support @ N.E. corner intersection

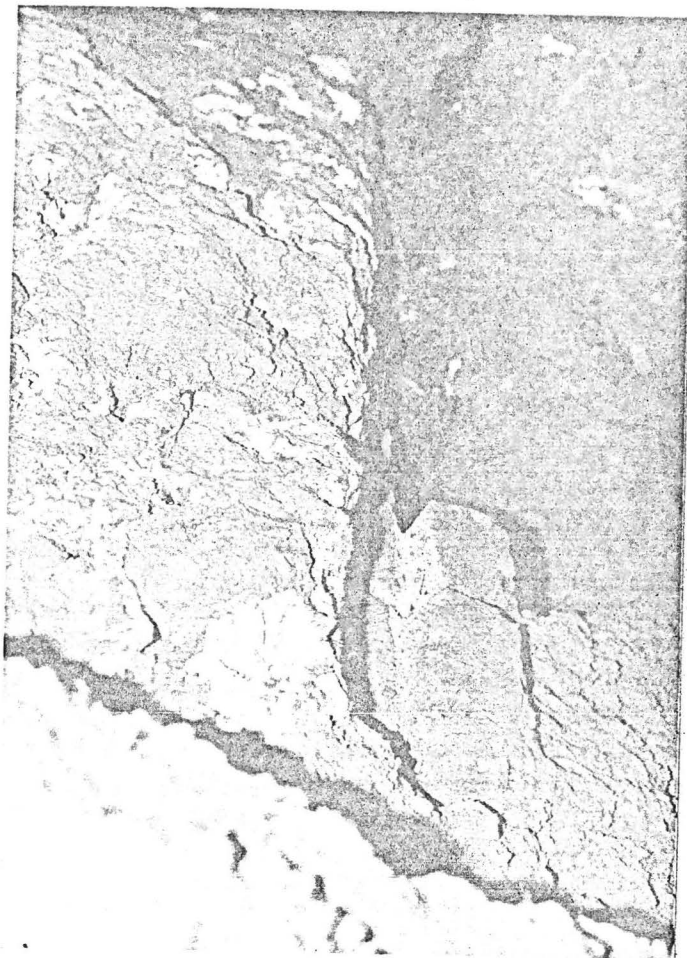
64. Footing of the West 1922 addition along the North Wall

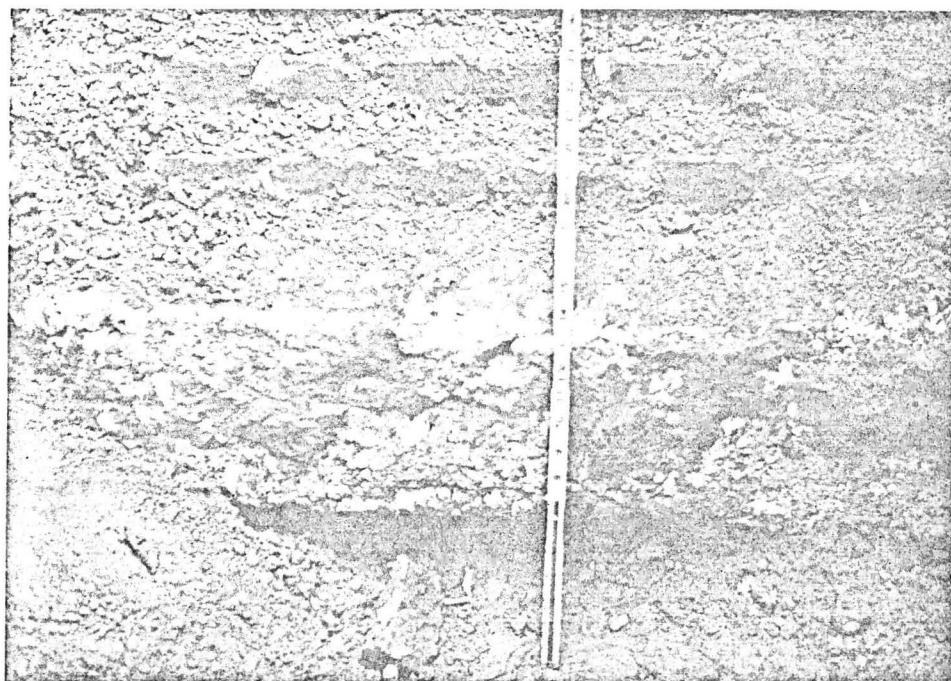
65. Concrete footing @ the West 1922 addition at North Wall Intersection
